Humboldt Community Services District Well Evaluation and Replacement

Sean Culkin, P.G., C.H.G., David Livermore, R.G., L.H.G., Eron Dodak, Stephen Sherman, Integral Consulting Inc.

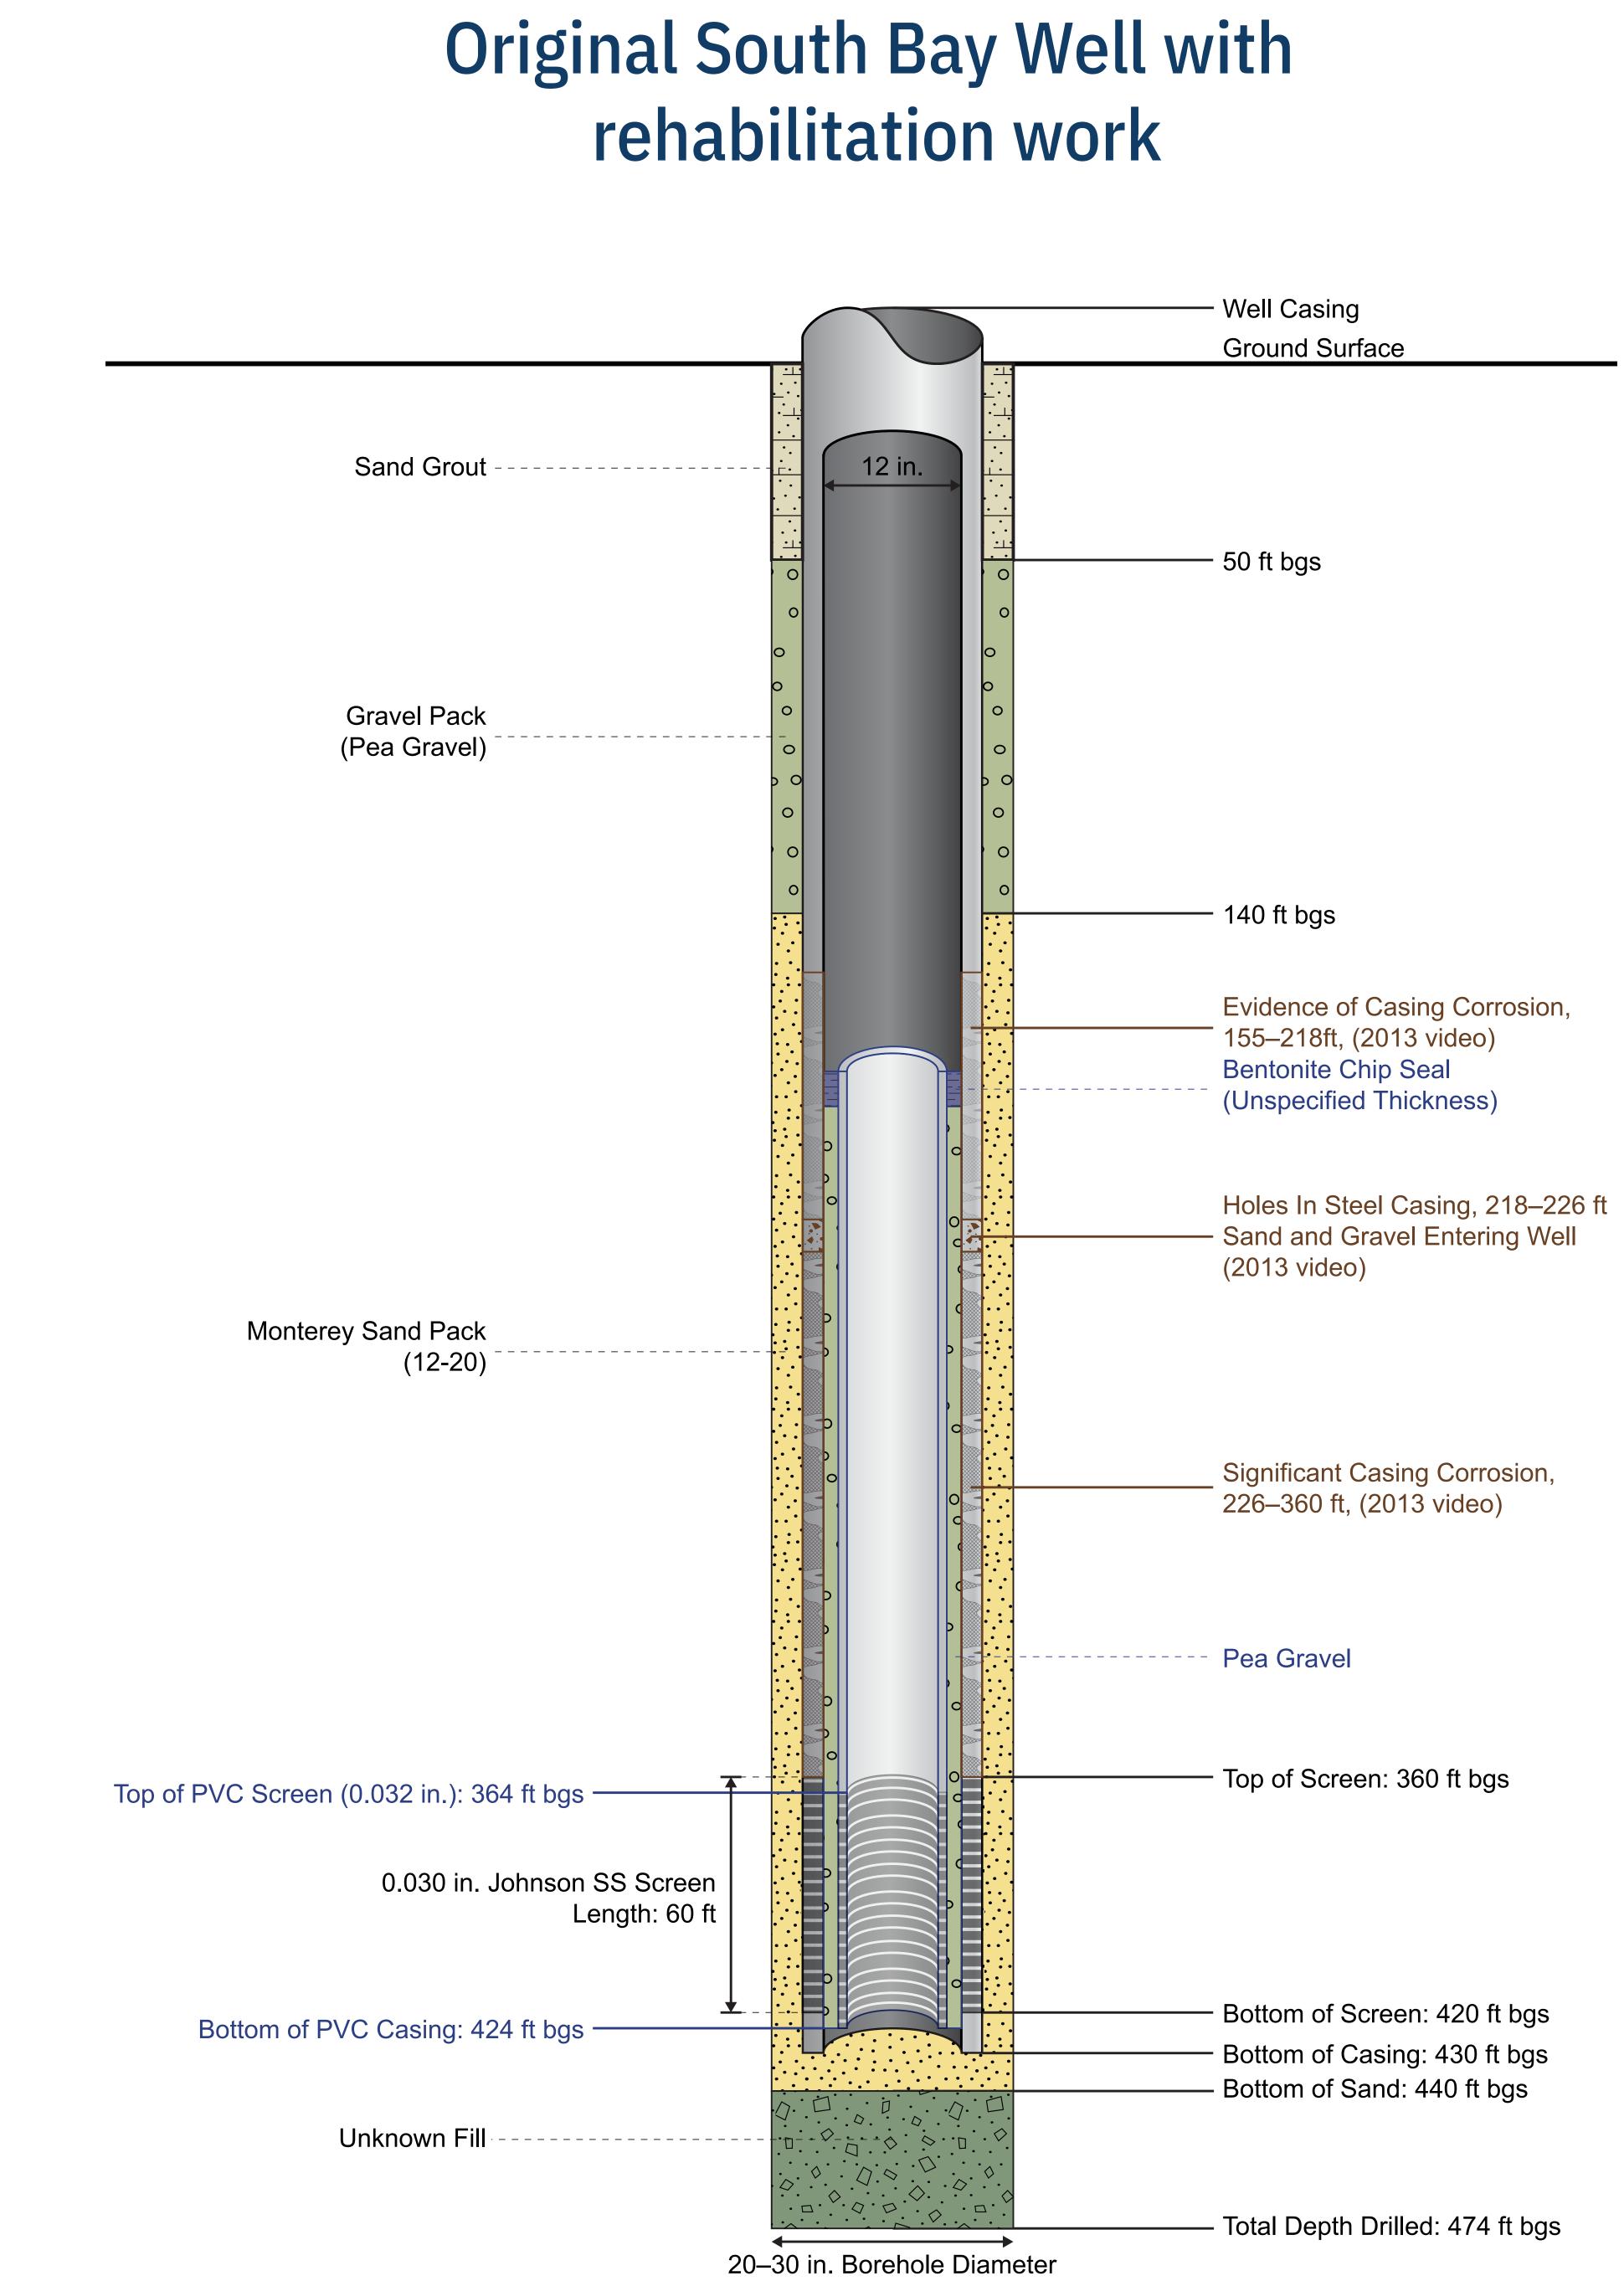
Original South Bay Well

- 12-in.diameter steel casing from ground surface to 360 below ground surface (bgs)
- 60 ft of 0.030 in. slot size stainless steel screen from 360–420 bgs
- 10 ft steel sump from 420–430 bgs

The original South Bay Well taps into the Pliocene Hookton formation, spanning 390 feet of the Hookton layer, overlying aquitard, and overlying Holocene unconsolidated alluvium.

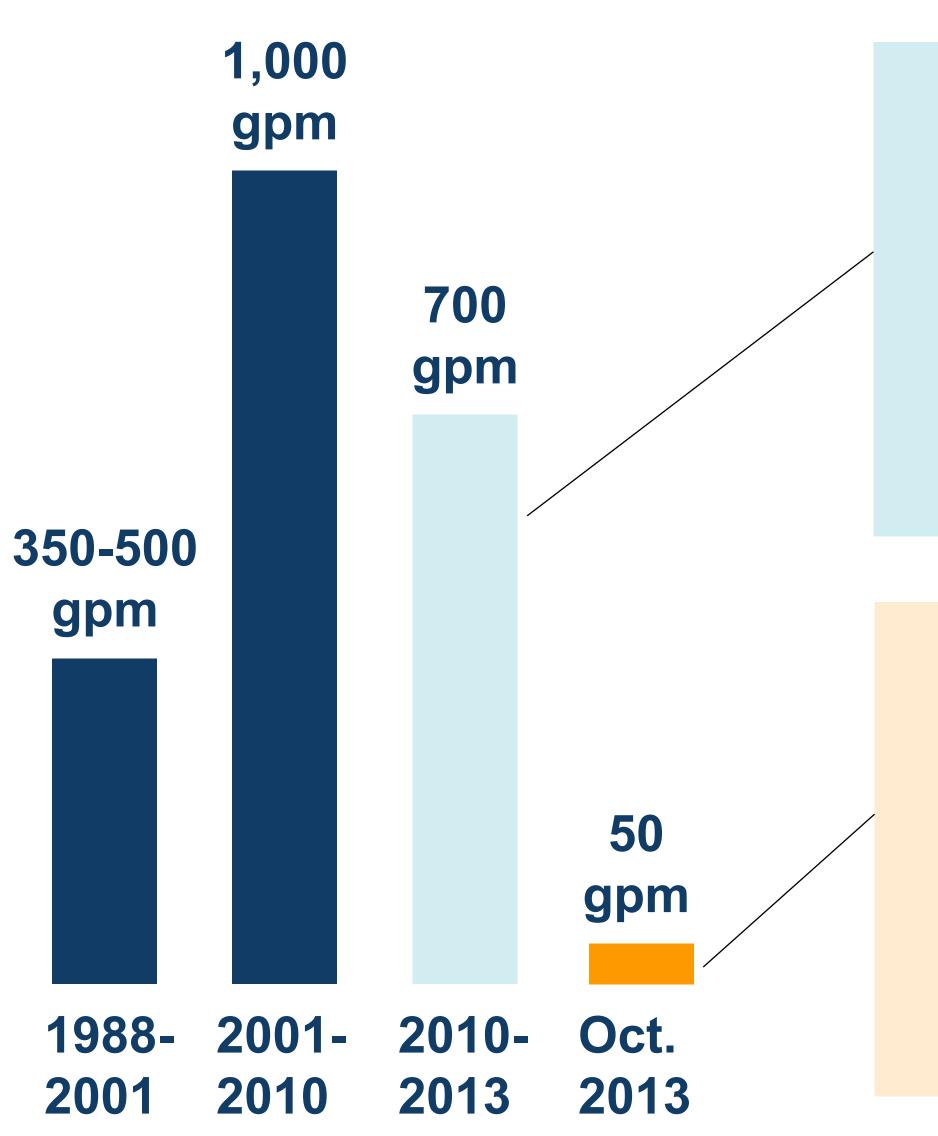
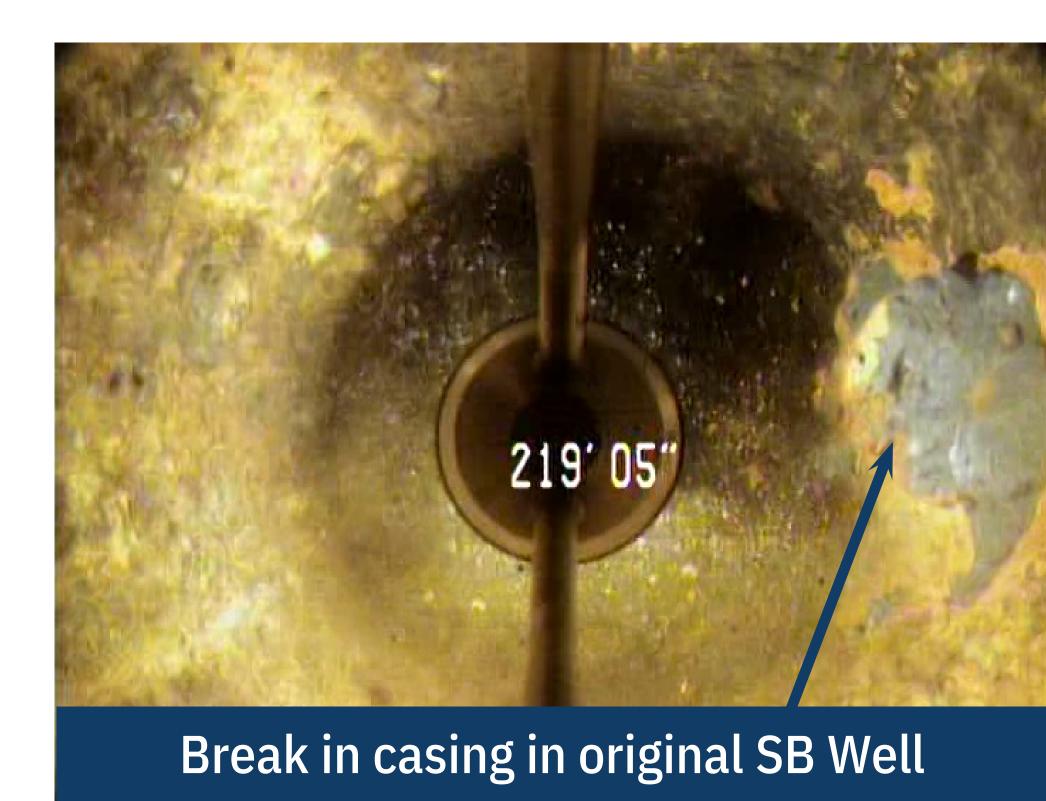
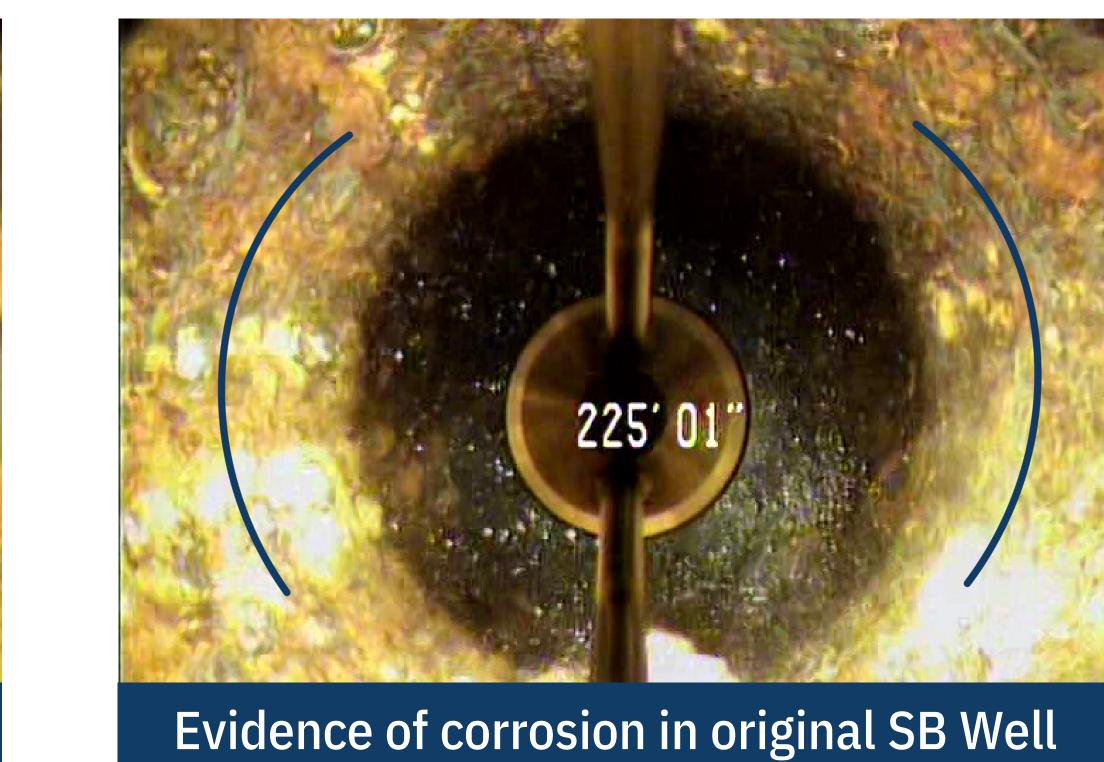
Well Failure and Diagnosis

In October 2013, pea gravel was entering the well, leading to a sharp decrease in flow to 50 gpm. The well was taken out of service.

A well video identified corrosion and holes in the casing at 218 to 226 ft bgs, which allowed the pea gravel pack to enter the well.

In December 2013, the District hired a well driller to rehabilitate the well. Rehabilitation consisted of installing an 8-in. diameter PVC casing inside the original casing. The bottom of the PVC casing extended to 424 ft bgs (6 ft above the original total depth). Sixty feet of 0.032-inch slot PVC casing was installed at the bottom, above which 180 ft of blank casing was installed to a depth of 184 ft bgs.

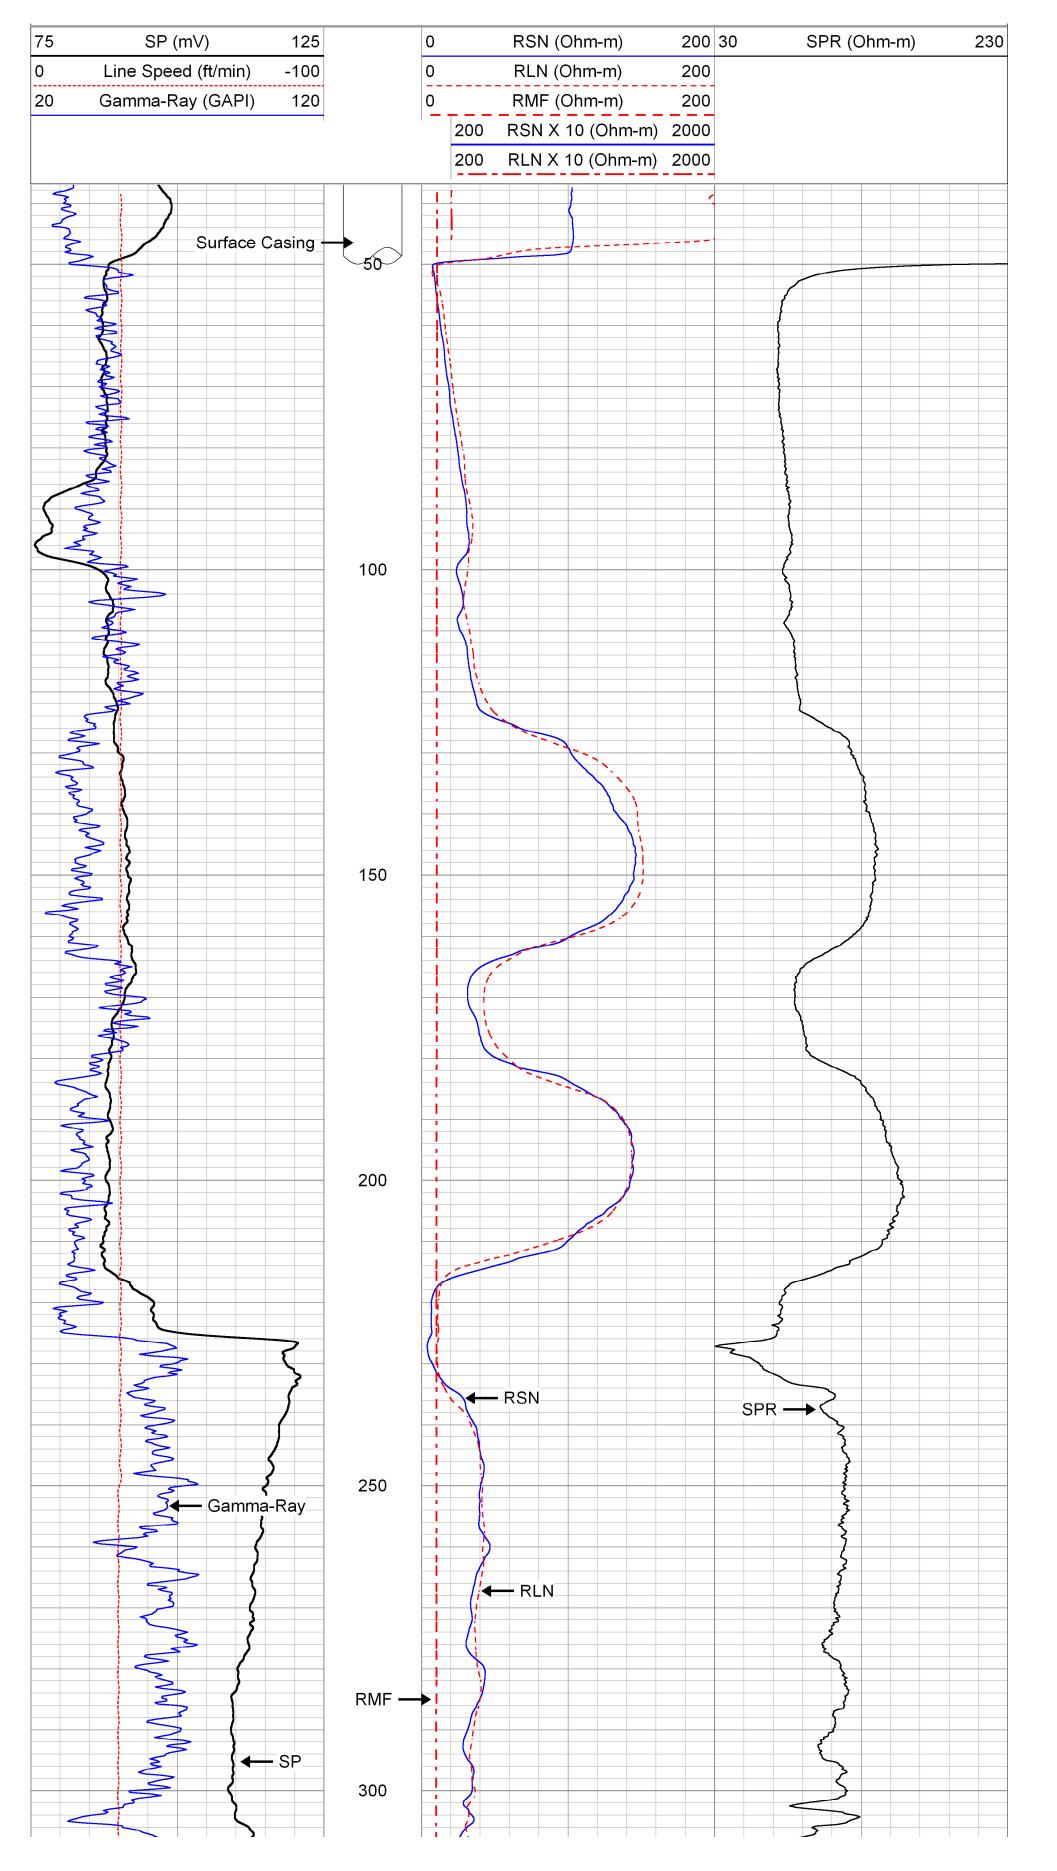
E-log of new South Bay Well with interpreted saline water zone at 225 ft bgs directly above the aquitard overlying the Hookton Formation

The well was constructed in summer 2018. After construction, an electric log identified the likely high-saline interval at 225 ft bgs—the same interval where casing corrosion and entry of the gravel pack was observed on the old well.

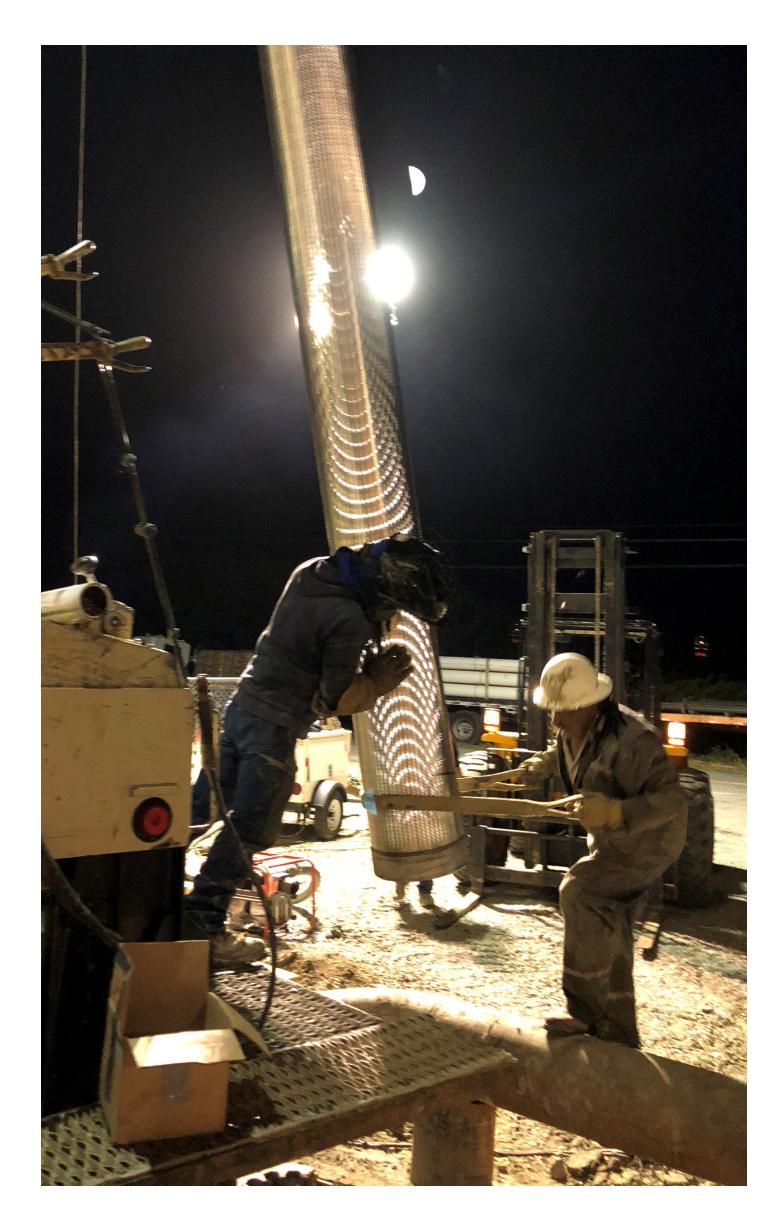
Well screen installation in new South Bay Well

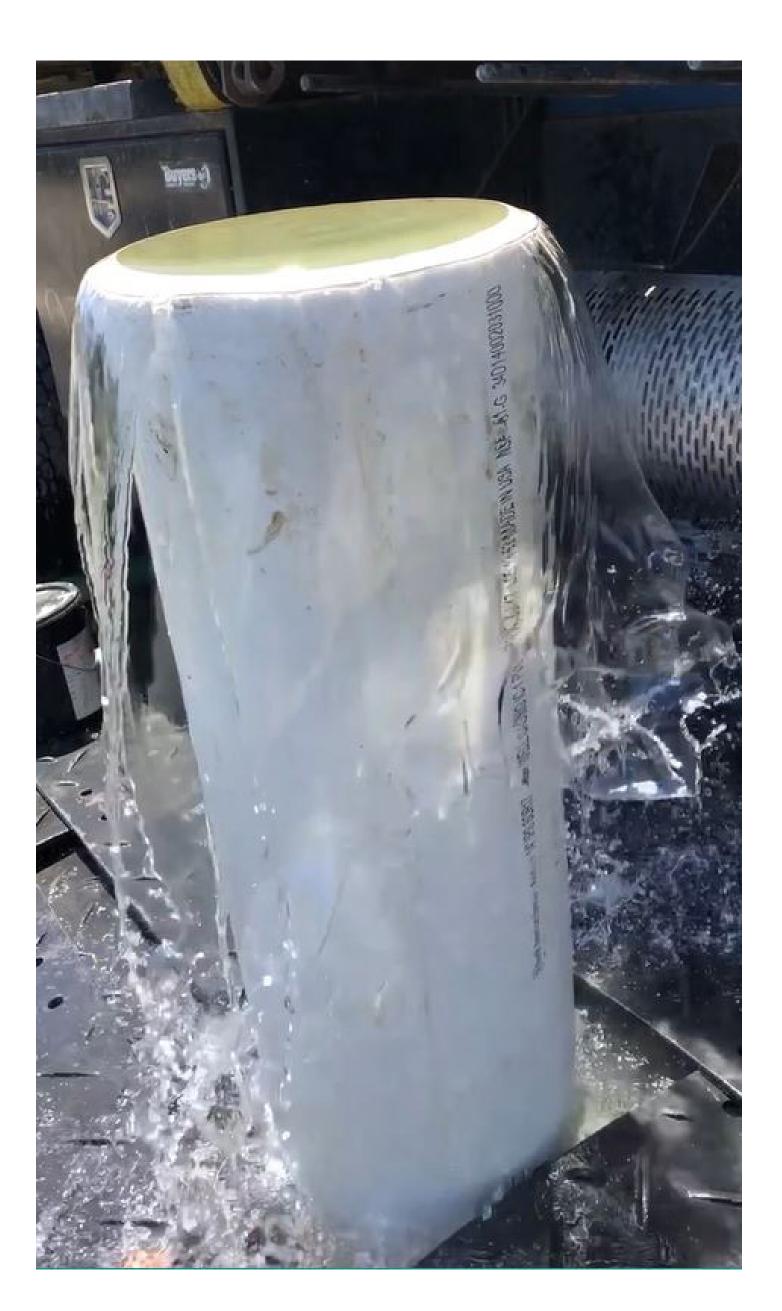
Artesian water flow from PVC casing of new South Bay Well
