Process-Based Approach to Understanding and Mitigating Erosion at Ecola Creek Study Site

KARA SCHEU, PH.D., ROBERT WALKER, P.E., DAVID REVELL, PH.D., INTEGRAL CONSULTING INC.

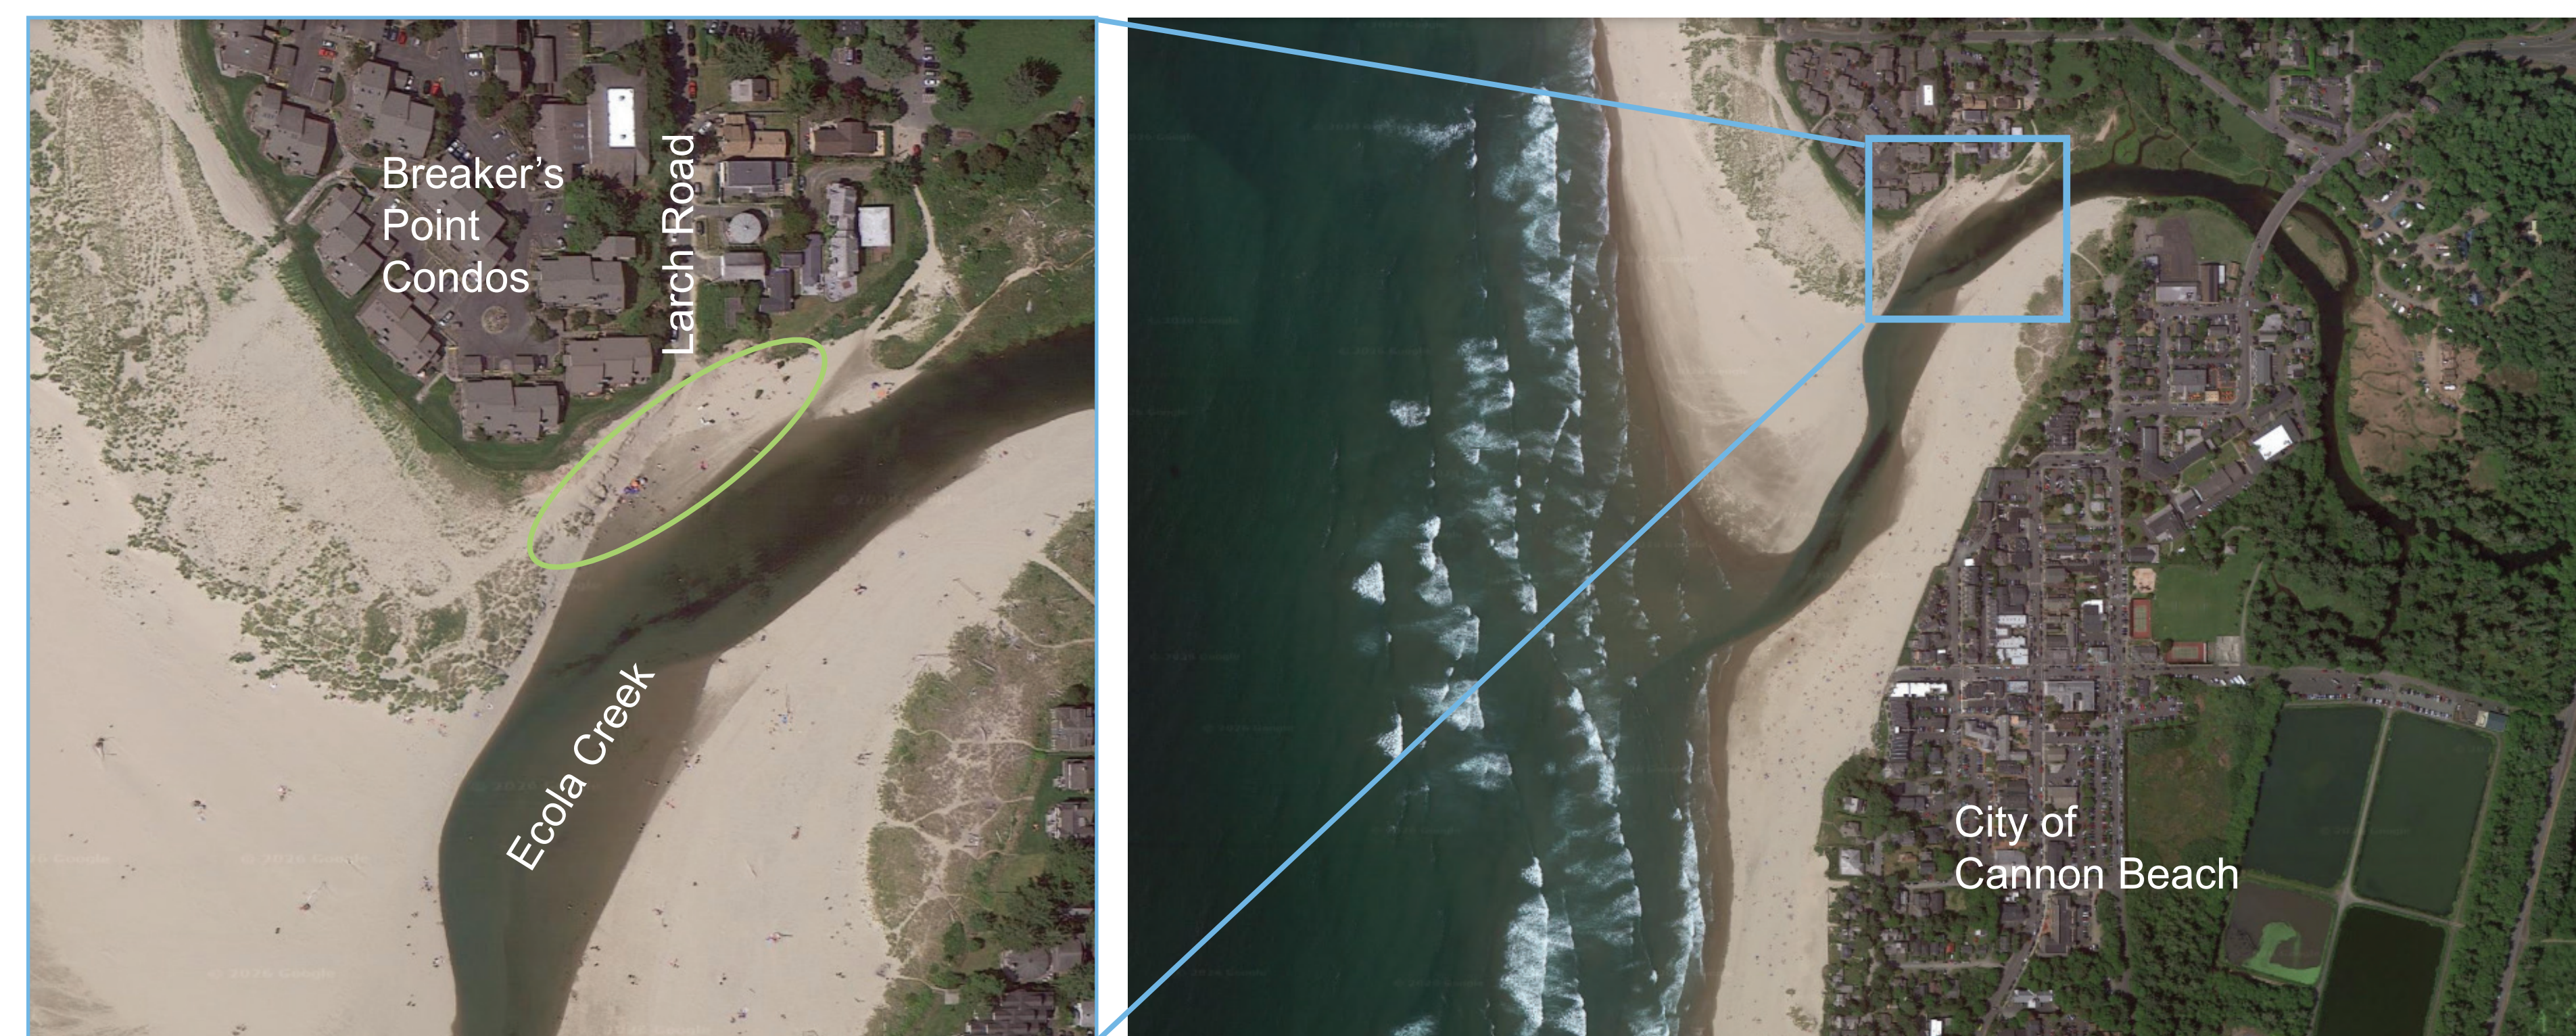
Figure 1. Project area (green oval) with key site features

Ecola Creek's north bank has experienced episodic erosion averaging 3 to 4 ft per year, and past mitigation efforts have repeatedly failed because the underlying processes were never fully characterized. The north side of Ecola Creek in Cannon Beach, Oregon, is an erosion hot spot shaped by compound coastal forcing including seasonal river flows, king tides, and large offshore waves. Infragravity waves and wave reflection off a seawall located on the other side of the river further increase vulnerability at the site. This ongoing erosion puts nearby homes, infrastructure, and recreational beach access at risk. Numerous prior stabilization attempts at the site have failed. This study takes a different approach, building a process-based understanding of what is actually driving erosion before proposing any design solution.

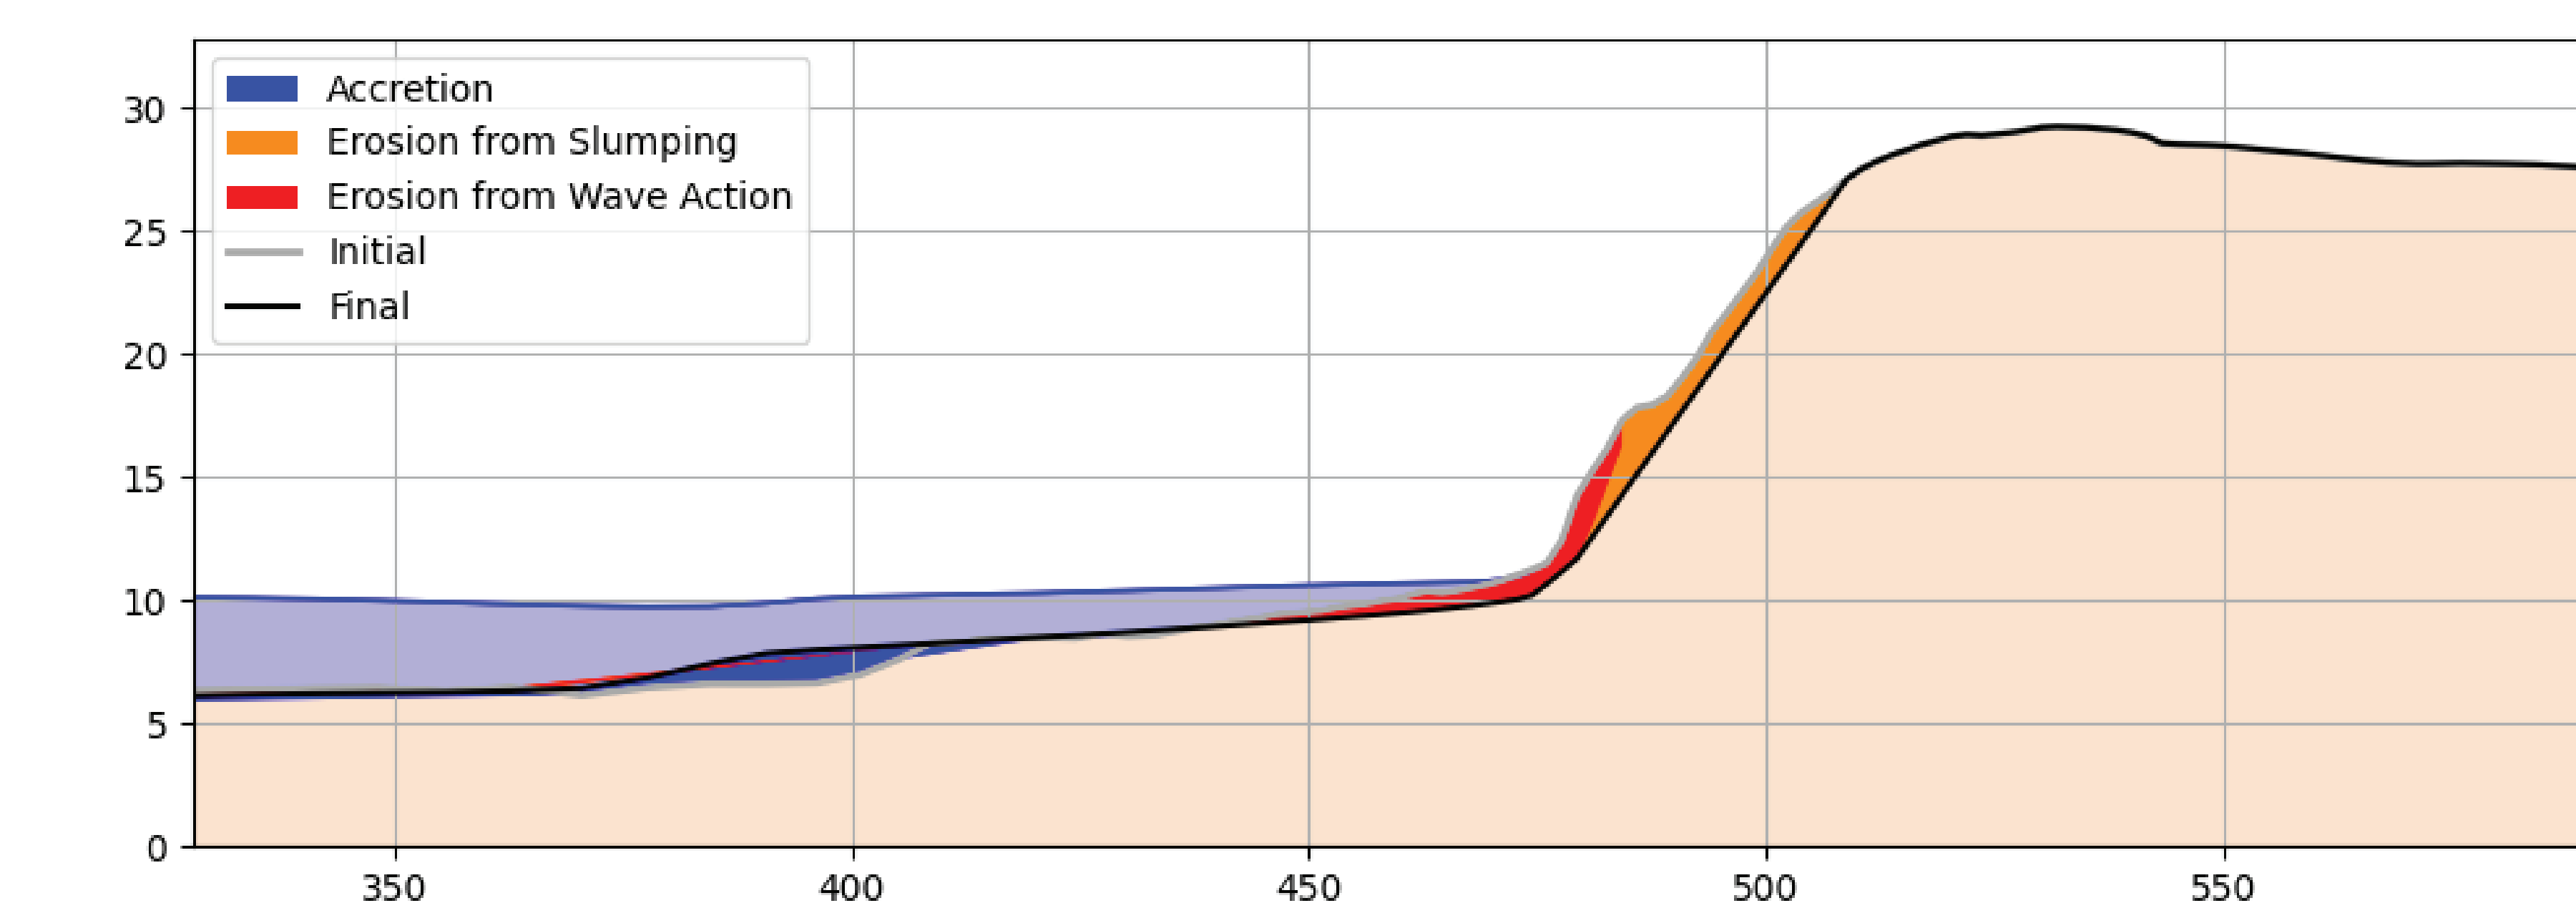
Figure 4. XBeach modeling of toe erosion and bank slumping

Toe erosion during episodic high water/wave events destabilizes the entire bank. Just a handful of events per year account for the full 3 to 4 ft of annual loss. Cross-shore erosion modeling (XBeach) shows that even moderate wave events at high water levels are sufficient to erode the bank toe, triggering destabilization and subsequent slumping of the bank face. This mechanism was confirmed by direct site observation.
