Mapping Dredging Residuals and Disposal Deposits

By Eugene C. Revelas, Senior Science Advisor, Integral **Nicole Ott,** Senior Consultant, Integral

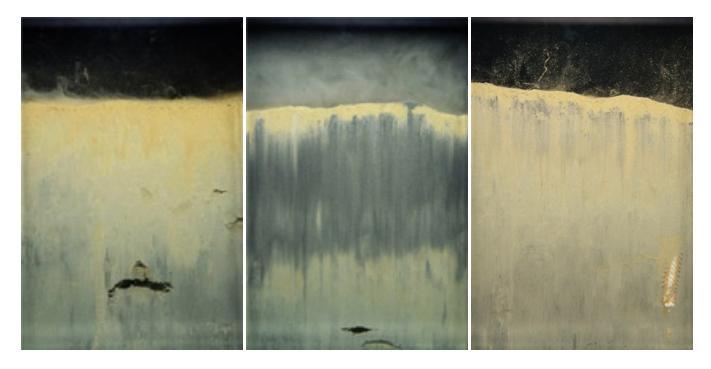
Figure 1. *Left:* A natural mud bottom at an offshore disposal site prior to disposal. *Middle:* The same area overlain by 9 cm of freshly disposed, reduced dredged material (black layer). *Right:* An outer area of the disposal site overlain by only 1 cm of freshly disposed dredged material after the same disposal event.

SPI surveys to accurately map dredged residual deposits during and immediately after environmental dredging operations. SPI technology has been used for decades to map deposits and benthic conditions at dredged material disposal sites. Because of the camera's unique ability to capture very high-resolution images of the upper 20 cm of the sediment column, very thin (centimeterscale) depositional layers, anthropogenic or natural, can be imaged and measured (Figure 1).

When the SPI camera is deployed during or immediately after a dredge disposal operation, the freshly settled deposits are readily apparent visually and can be accurately mapped to centimeter scales in near real time. In most sedimentary settings, biological reworking quickly mixes thin deposits into the ambient bottom and

the visual evidence of its presence fades within days to weeks. The 1 cm layer of dredged material in the right image below is in the process of being "erased." That image was collected 1 week after the dredged material was disposed.

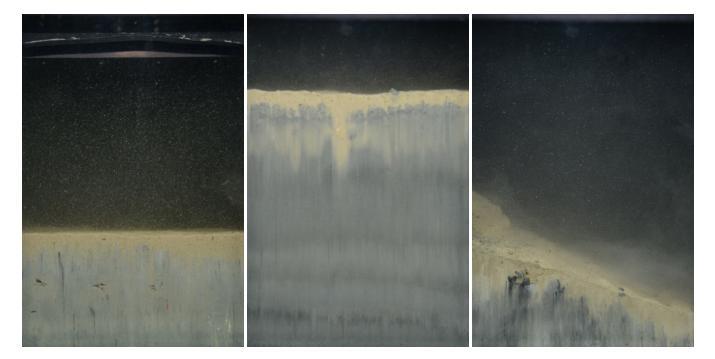
Figure 2. *Left:* A compact mud bottom in Douglas Harbor, Alaska, before dredging took place in November 2015. *Middle:* An area of the harbor less than 2 weeks after dredging showing multiple layers of generated residual deposits. In addition to the residual layers (gray and black banded layers), the deeper SPI penetration is indicative of unconsolidated, freshly settled material. *Right:* An area of the same harbor following dredging; the SPI image shows a compact sediment bed (relatively shallow prism penetration) lacking obvious generated residual layers.

Similarly, when SPI surveys are conducted at dredging sites immediately after dredging, generated residual deposits can be readily detected (Figure 2). Rapid deployment of the SPI camera throughout and surrounding a recently completed dredging operation
